DEPARTMENT OF TRANSPORTATION

Quality Assurance and Source Inspection

Contract #: 04-0120F4Cty: SF/ALA Rte: 80 PM: 13.2/13.9File #: 1x.28**WELDING INSPECTION REPORT****Resident Engineer:** Casey, William**Address:** 333 Burma Road**City:** Oakland, CA 94607**Report No:** WIR-027456**Date Inspected:** 17-Apr-2012**Project Name:** SAS Superstructure**OSM Arrival Time:** 700**Prime Contractor:** American Bridge/Fluor Enterprises, a JV**OSM Departure Time:** 1730**Contractor:** American Bridge/Fluor Enterprises, a JV**Location:** On Site**CWI Name:** Sal Marino**CWI Present:** Yes No**Inspected CWI report:** Yes No N/A**Rod Oven in Use:** Yes No N/A**Electrode to specification:** Yes No N/A**Weld Procedures Followed:** Yes No N/A**Qualified Welders:** Yes No N/A**Verified Joint Fit-up:** Yes No N/A**Approved Drawings:** Yes No N/A**Approved WPS:** Yes No N/A**Delayed / Cancelled:** Yes No N/A**Bridge No:** 34-0006**Component:** SAS OBG Components**Summary of Items Observed:**

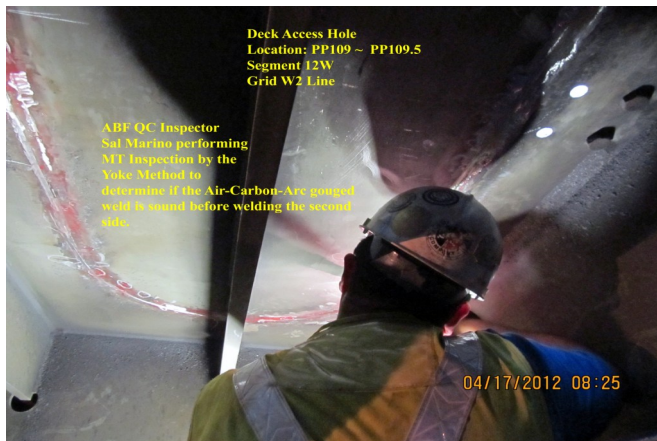
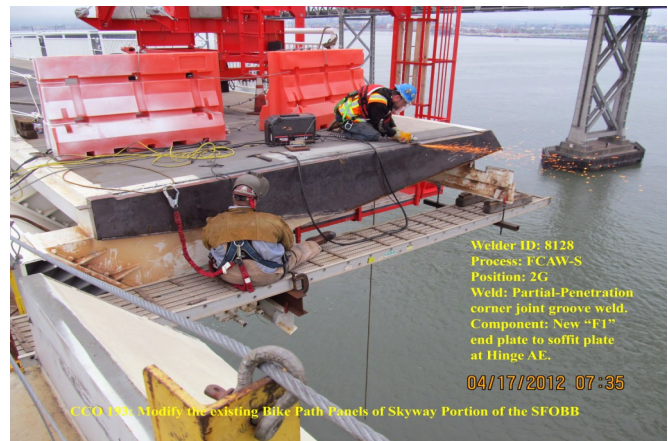
This QA Inspector randomly observed ABF welder Jason Collins (Welder ID 8128) performing the root, fill, and cover pass weld operation on a partial-joint-penetration (PJP) groove weld per the Shielded Metal Arc Welding (SMAW) process in the (2G) horizontal position connecting the new end plate "F1" to the existing soffit plate of the bike path box panel at the expansion joint hinge "AE" as per ABF Submittal no. 2549R2 of Contract Change Order (CCO) 193.

The root, fill, and cover pass weld operation connecting the new end plate "F1" to the existing bike path box panel's soffit plate was still in-process at the end of this QA Inspector's shift.
